DMR-9903702

PI: M. Skowronski (GOALI project, in collaboration with SUNY Stony Brook, ABB and Cree)

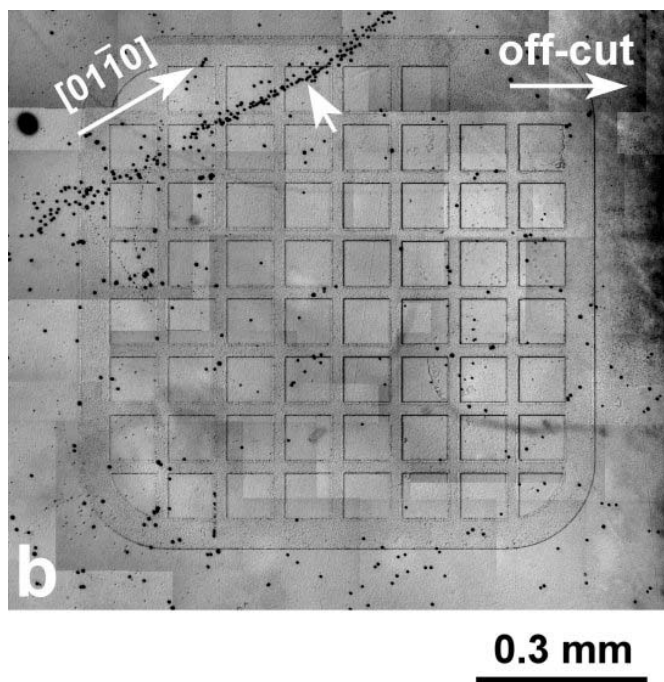
Upper figure shows an optical top view image of high voltage SiC diode with location of crystalline defects delineated by etching (dark dots). Diode area contains low angle grain boundary generated during growth of SiC wafer (row of pits in upper left corner) as well as other types of dislocations.

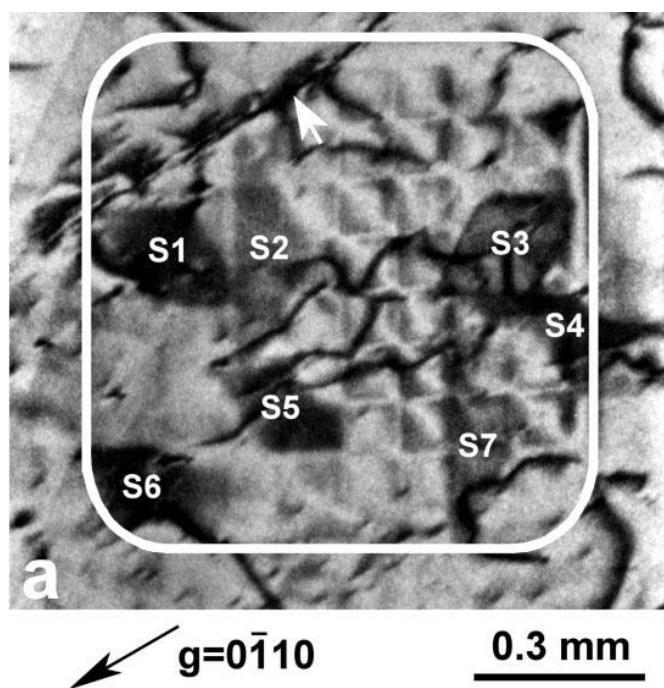
Lower figure is the transmission synchrotron white beam x-ray topograph of the same diode after electrical stress for 10 minutes and 1 Ampere. The dark diamond- and triangle-shaped areas correspond to stacking faults produced by current flow. The starting point for two of these defects (S1 and S2) are located at the low angle grain boundary.

The development of silicon carbide technology is driven by its potential applications in high voltage switching systems for efficient electric power distribution and electric vehicles. It was recently discovered that high voltage bipolar SiC devices severely degrade during current injection with degradation occurring through growth of stacking faults in SiC epilayers (shown in upper figure). Carnegie Mellon University together with ABB and Cree is working to produce stable and reliable SiC electronic devices. CMU work will identify the source of stress that causes fault expansion. Current hypothesis is the change of lattice parameter due to doping differences in p^+n^- structures. Also degradation can be prevented by identification and elimination of fault nucleation sites. One such site (low angle grain boundary in figures above) has been identified. Its origin is due to excessive temperature gradients during bulk crystal growth. Grain boundaries replicate from SiC wafers into epilayers during epitaxy. The solution is improved crystal growth with properly designed thermal gradients in the hot zone.
